# CLEAN SLATE

## RESTORING NATURAL SLATE ROOF TAKES EXPERT CRAFTSMANSHIP

**HOWARD W. JONES HALL**  
**YOUNGSTOWN STATE UNIVERSITY**  
 YOUNGSTOWN, OHIO

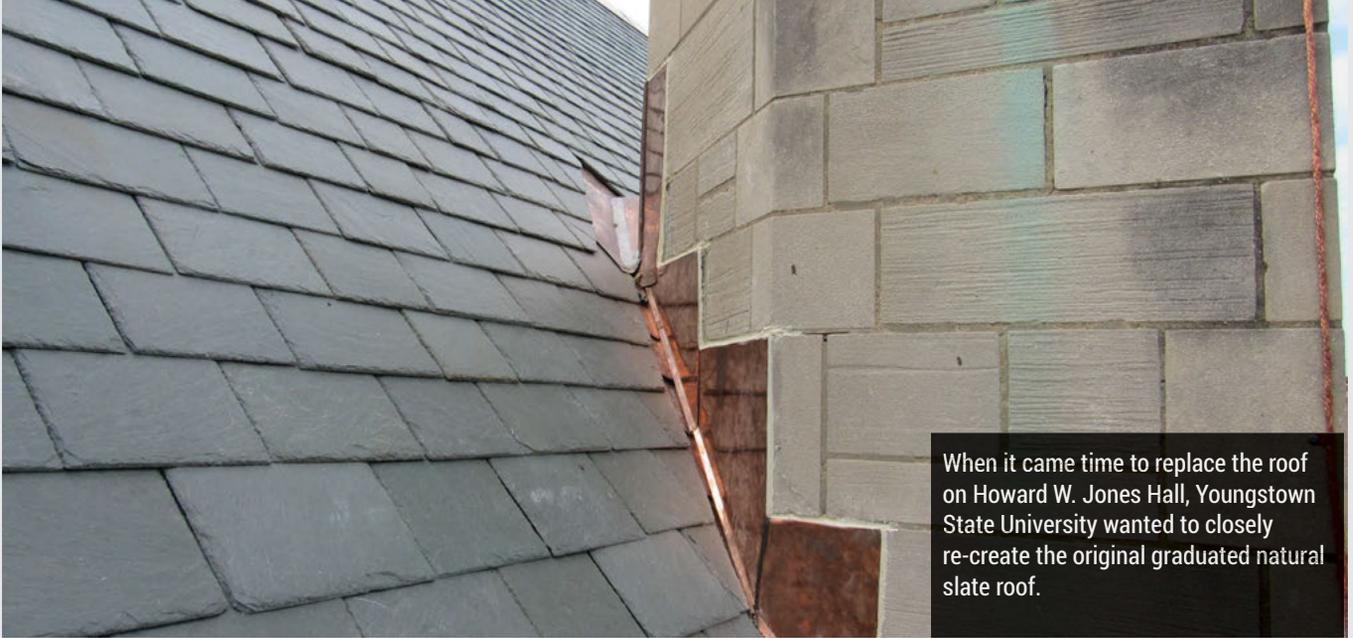
When it came time to replace the roof on Howard W. Jones Hall, Youngstown State University wanted to closely re-create the original graduated natural slate roof.

The existing wood plank deck was in very good shape, and Carlisle Water & Ice Protection self-adhering underlayment was installed at the eaves, valleys and rakes. It was also applied around all of the details. Then two layers of 30-pound felt were tacked into place with plastic-capped nails.

Natural hand-split roofing slate was delivered pre-cut and pre-punched by Evergreen Slate Co., located in upstate New York. The slates were mixed to ensure proper color distribution and arranged in piles for installation on the site. Once the underlayment was in place, the slate was installed just as it might have been a century ago. "We used copper nails," Dennison notes. "Everything was nailed by hand—two nails per slate."

The installation called for a 3-inch head lap. “With random slate, you don’t need to put any vertical lines in, because nothing is going to line up vertically,” Dennison explains. “Every side lap has to be at least 3 inches, but there is no set pattern for the widths—we just mix them up. That’s why they use the term ‘random.’”

Handcrafted copper details completed the distinctive, traditional look. Flat-seam copper panels from Revere Copper were installed in the valleys, using clips to allow for expansion and contraction. Copper counterflashing and step flashing were also custom fabricated. “We bend it to fit whatever we might need,” notes Dennison. “We have a talented sheet metal shop at our office where we fabricate the big stuff, but we also cut and shape panels on site.”
