# RESTORING LADY LIBERTY

## CHARLES F. EVANS HELPS RENOVATE BRADFORD COUNTY COURTHOUSE

Bradford County Courthouse

Towanda, Pa.

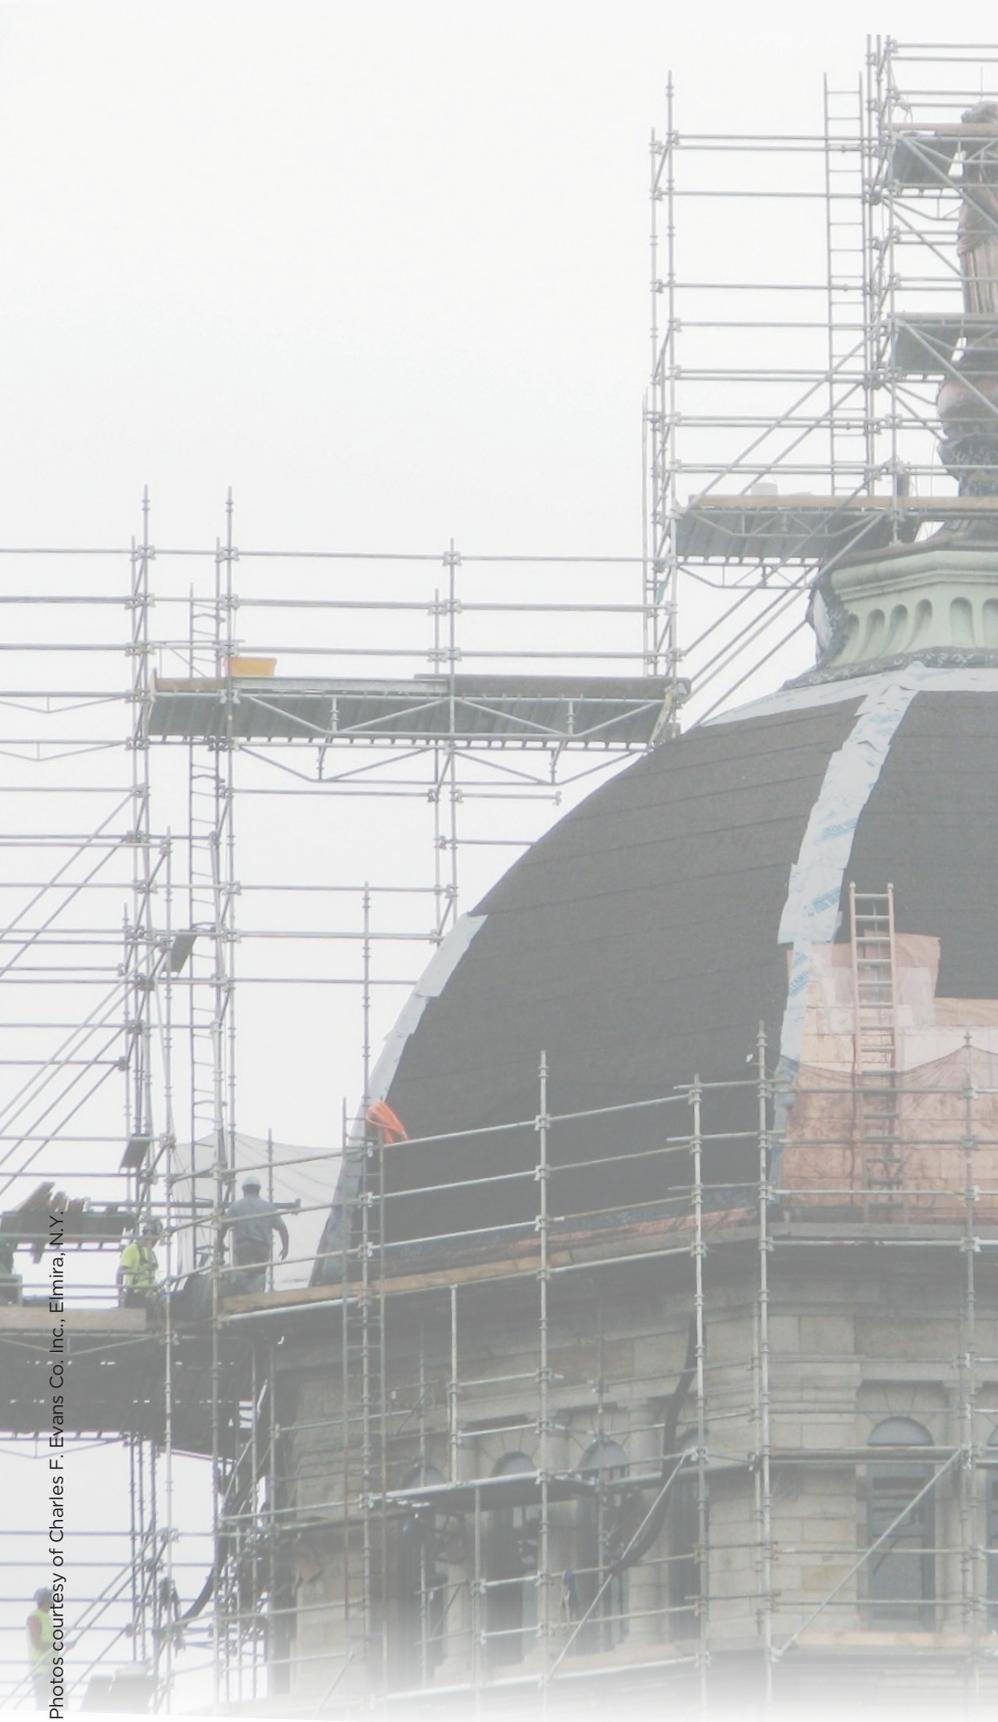
Top to bottom: Lady Liberty undergoes repairs; sheet metal mechanics custom-fabricated new copper flashings, gutters, downspouts and ventilation pieces; an aerial view of Bradford County Courthouse's new roof systems

As a result of weak spots and degrading copper created by more than a century of exposure to the elements, workers also performed intricate repair work to the statue of Lady Justice at the dome's peak.

"Charles F. Evans refurbished our 'Lady Liberty,' a copper monument at the peak of the dome," Corbett says. "She had withstood the weather for almost 120 years and had numerous coats of paint on her. They meticulously stripped, cleaned, repaired and brought her back to her original beauty."

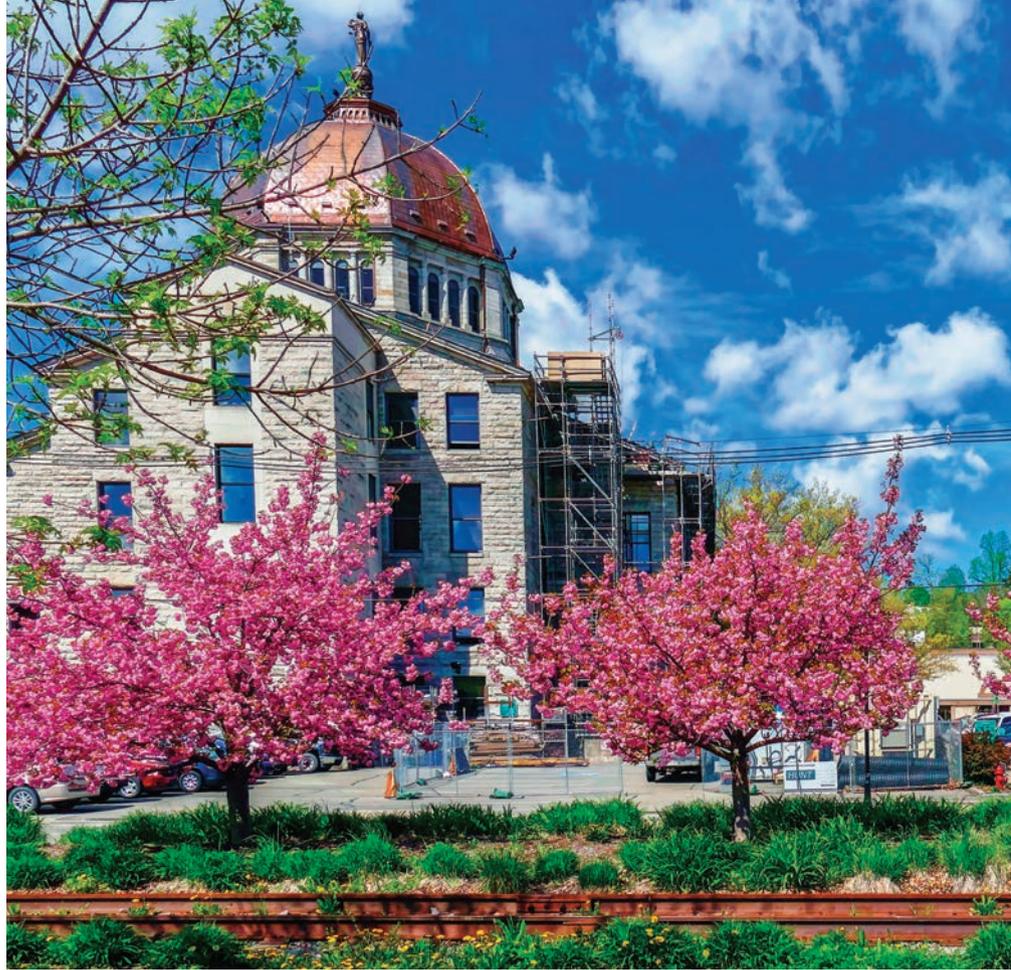
Bradford County Courthouse’s new copper dome

Phase one began in April 2016 and involved work on the dome. Charles F. Evans workers removed the existing, deteriorated terracotta roof tiles. As demolition work began, workers discovered the original tiles had been poorly secured to the roof framing that also was poorly installed on the dome structure.

Workers fastened new wood blocking to support new plywood sheathing followed by two layers of 30-pound felt. Because of the dome's 29-foot-wide radius, workers rechecked field measurements and adjusted the widths of flat-seam panels. Workers then fastened 3,300 square feet of flat-seam, 20-ounce, cold-rolled Revere copper panels on the courthouse's dome. As workers reached the top of the dome with a 4:12 slope, the panels were soldered.
